Manhole Inspection Summary

Manhole # S23CC1011MH

Location Address: **3600 CLIPPER MILL RD**

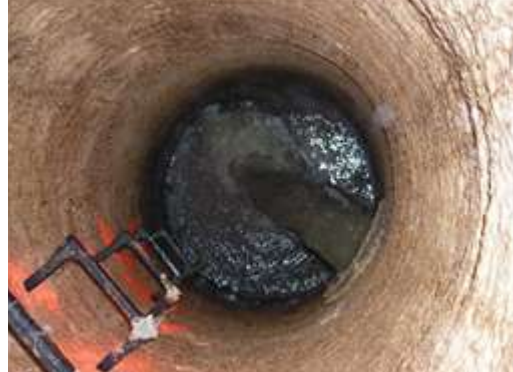
Top View

Comments **Portions of the Barrel are not lined.**

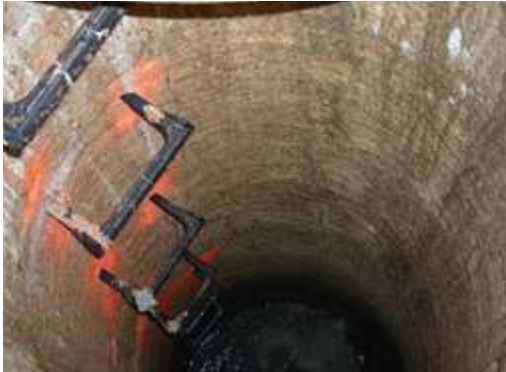
Defect

Adjustment and Barrel infiltration.

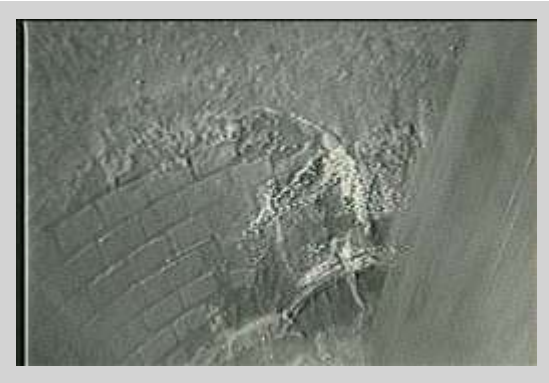
18 in. Circular Gravity Sewer Pipe Out @ 12 O'Clock

Barrel deterioration, loose brick and infiltration.

Infiltration: **Evidence** Pipe Seal Cond: **Broken**

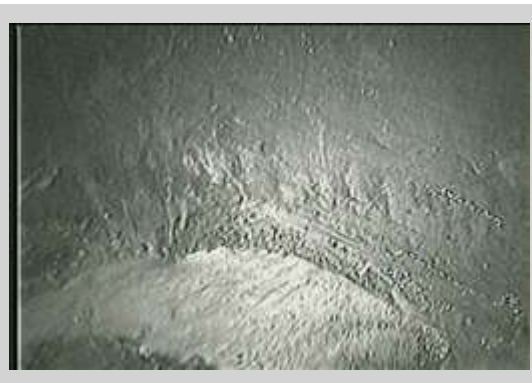
Drop In @ 4 O'Clock

Drop Condition: **Clogged**
